June 5, 1987

FROM: Frank J. Filas, Reclamation Engineer

RE: Site Inspection, Mi Vida Mine, M/037/028

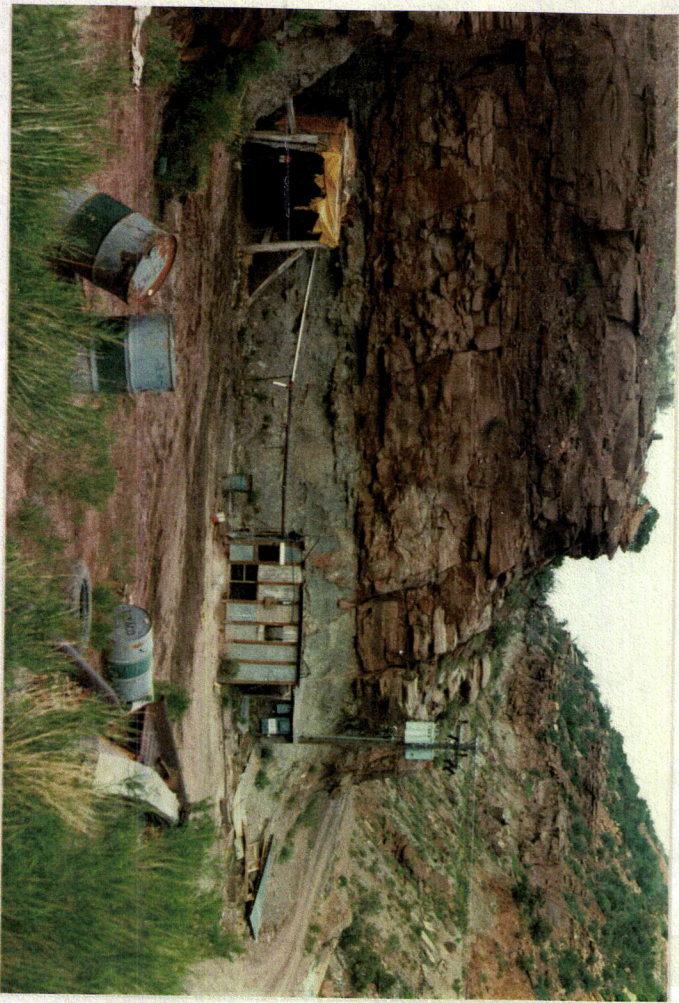
Dump Point at the McCormick Site  
5/87 M/037/028

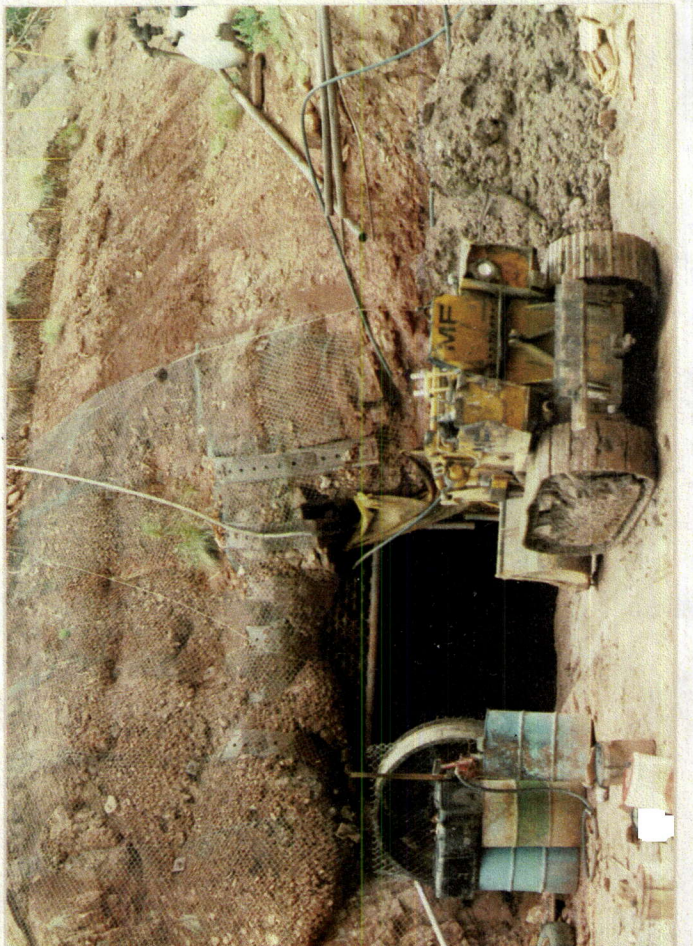
M/037/028  
Looking down Canyon from  
Expectation Site

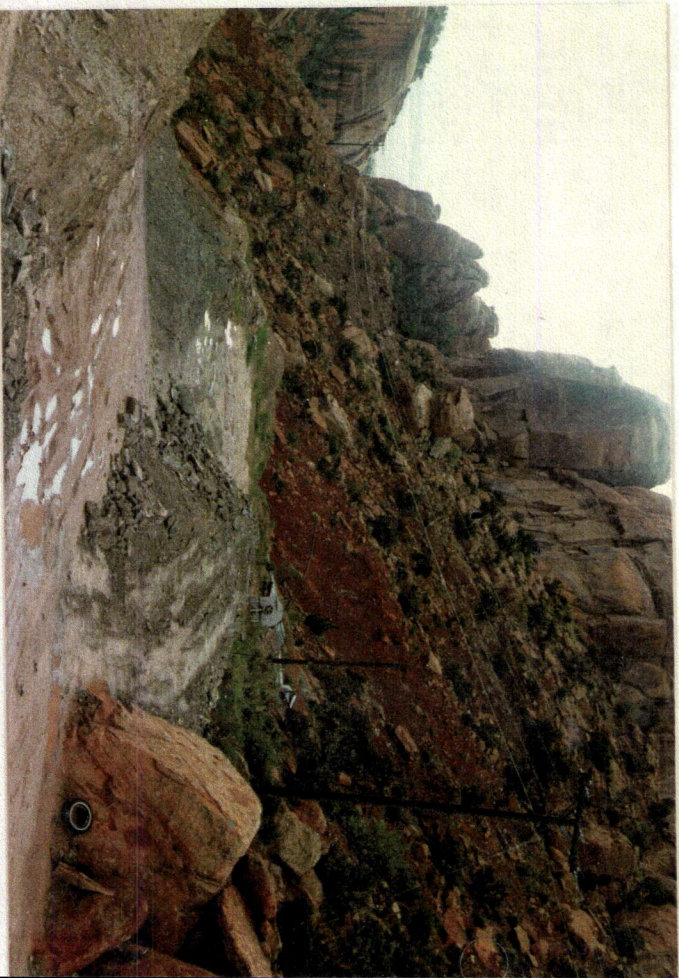
M/037/028 5/87  
McCormick Tunnel
